AD NUMBER	
AD357977	
CLASSIFICATION CHANGES	
TO:	UNCLASSIFIED
FROM:	SECRET
LIMITATION CHANGES	
TO: Approved for public release; distribution is unlimited. Document partially illegible.	
FROM: Distribution authorized to U.S. Gov't. agencies only; Administrative/Operational Use; 1953. Other requests shall be referred to Atomic Energy Commission, Washington, DC. Document partially illegible.	
AUTHORITY	
AEC ltr 16 Jun 1980 ; AEC ltr 16 Jun 1980

The purpose of Signal Corps participation in Project 3.20 was to determine the amounts of thermal flux (cal) and peak overpressure (psi) required to cause severe, moderate, light, and negligible damage to selected signal communications-electronics items of equipment and material for which inadequate or no data existed. Knowing these factors it is believed that responsible signal officers can better plan their tactical communications systems and take passive protective measures to reduce damage and losses to acceptable minimums. These data will also be used to improve design of equipment and material.

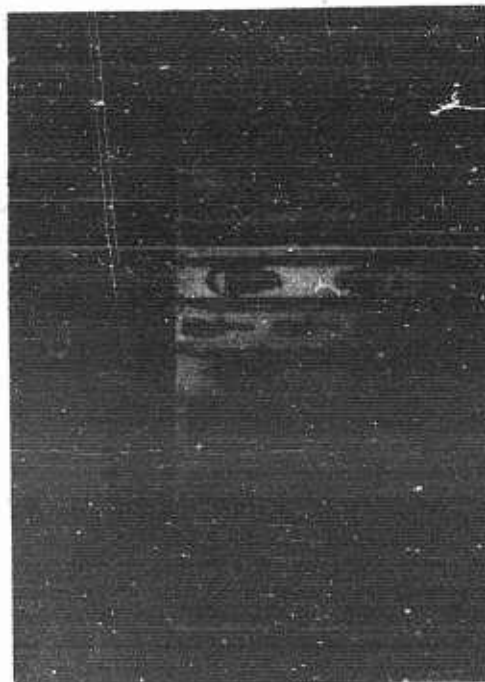
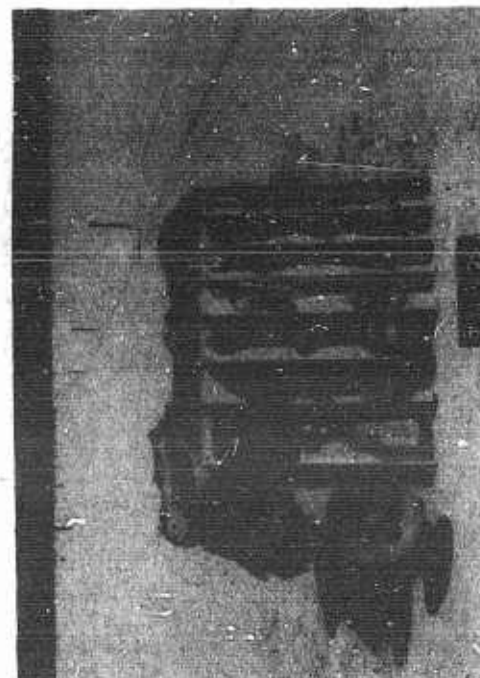
Fig. 3.81 Shot 9, Test Group 21, Exposure Board.
(Top-before, Bottom-after)
6800 ft, 16.5 cal, 4.2 psi.

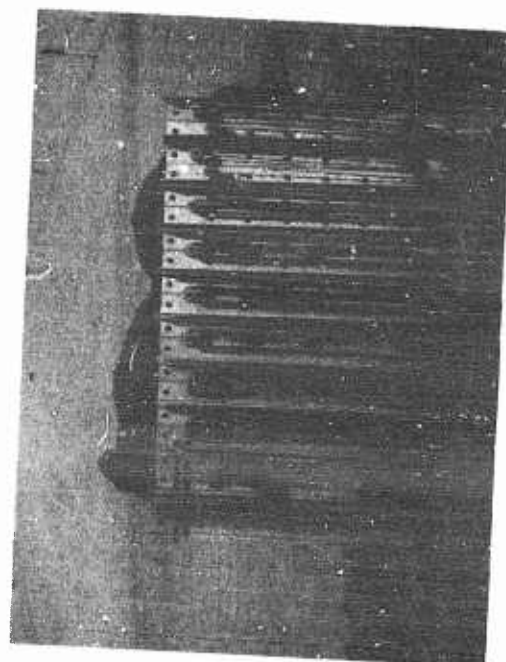
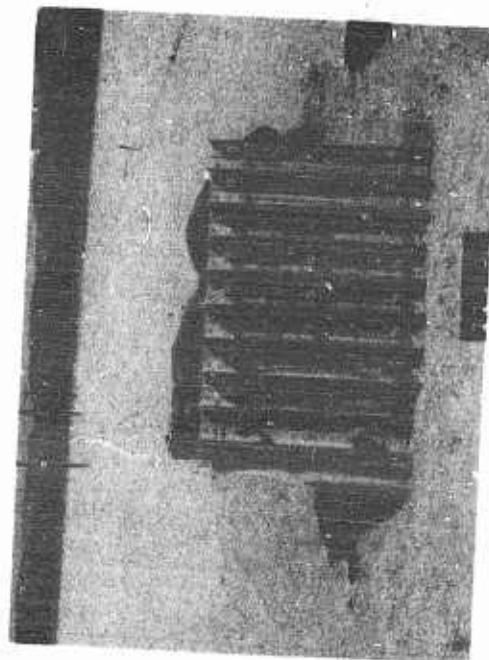
Fig. 3.82 Shot 9, Test Group 22, Exposure Board.
(Top-before, Bottom-after)
7800 ft, 10.8 cal, 3.4 psi.

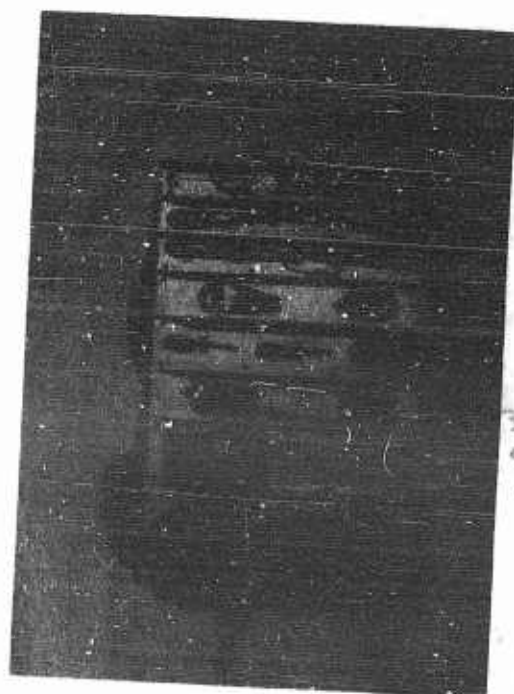
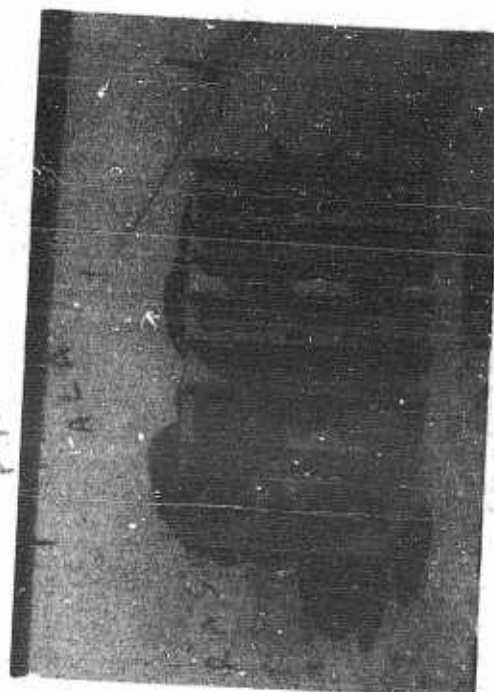
Fig. 3.83 Shot 9, Test Group 23, Exposure Board.
(Top-before, Bottom-after)
7800 ft, 10.8 cal, 3.4 psi.

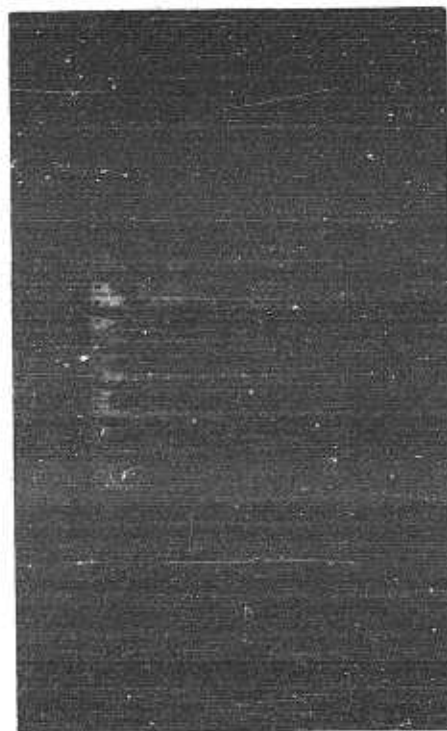
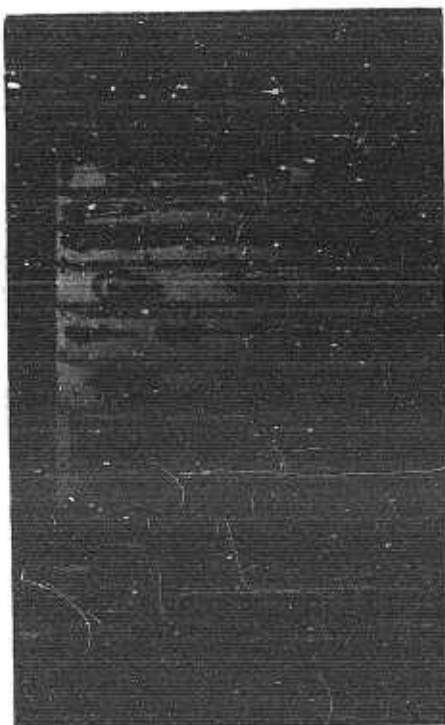
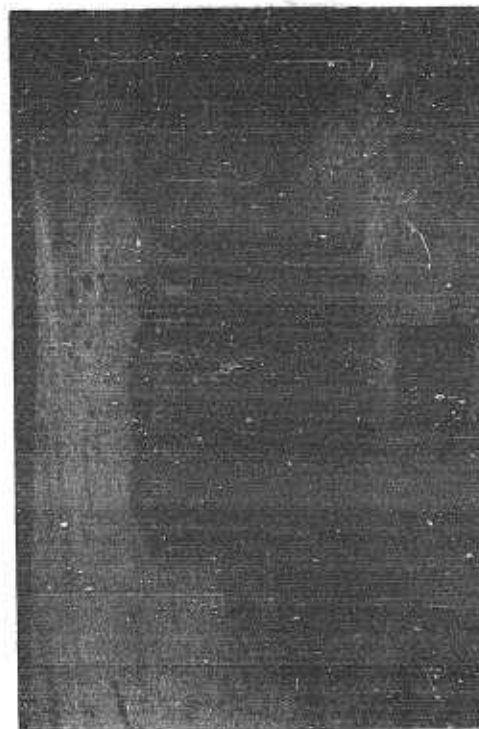
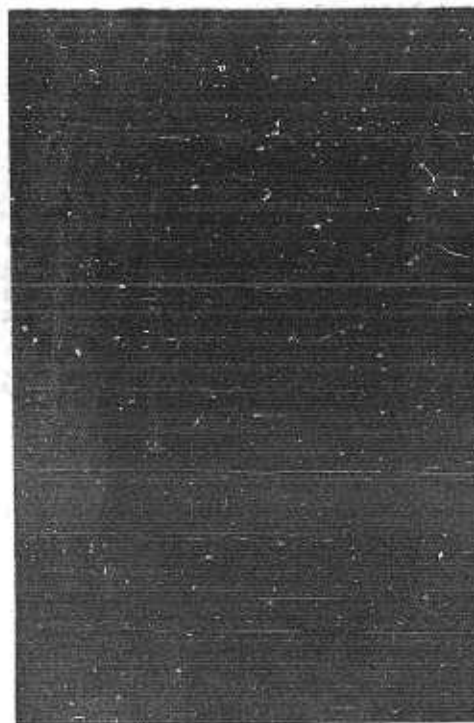
Fig. 3.84 Shot 9, Test Group 98, Exposure Board.
(Top-before, Bottom-after)
8800 ft, 9.5 cal, 3 psi.

Fig. 3.85 Shot 9, Test Group 99, Exposure Board.
(Top-before, Bottom-after)
8800 ft, 9.5 cal, 3 psi

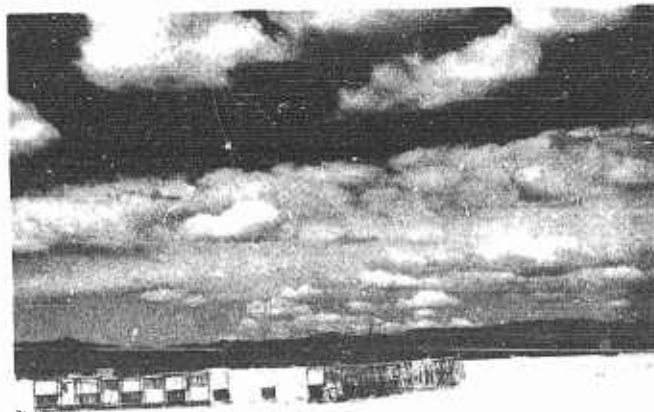
33

b. RESULTS: Severe damage by blast forces. Tower collapsed. Study of high speed photography indicates that basic tower failure occurred between ground and the first guy level. The base and third section from bottom were demolished. Members were severely bent or broken. Adjustable feet at base section were severed. Examination of individual tower sections revealed that only 5 sections could be reused. Fifteen sections were sufficiently damaged to require replacement. Small diagonals (1 inch diameter tubing) in many of the damaged sections failed in either tension or compression. The tensile failure caused the two rivets to be sheared at either end of the diagonal. The compression

Fig. 3.86 Shot 9, Test Group 33, Tower, 120 ft.
(Top-before, Bottom-after)
3350 ft, 51.5 cal, 9.8 psi.

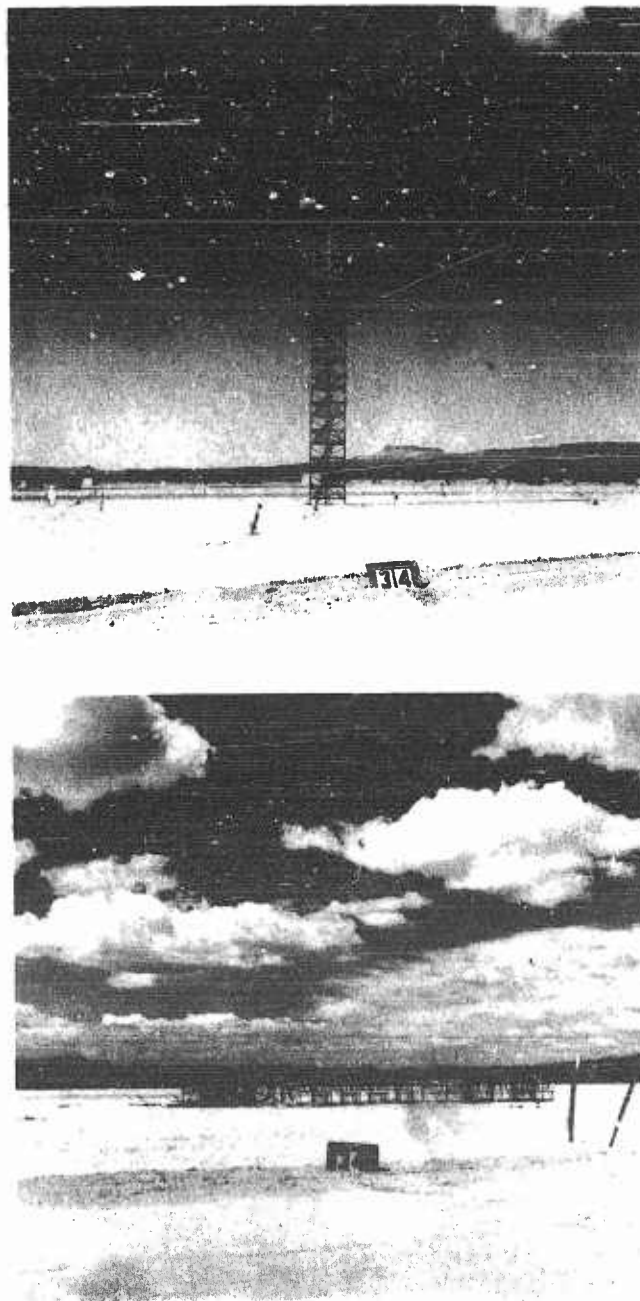
Fig. 3.88 Shot 9, Test Group 34, Tower, 120 ft.
(Top-before, Bottom-after)
4350 ft, 36 cal, 7.2 psi.

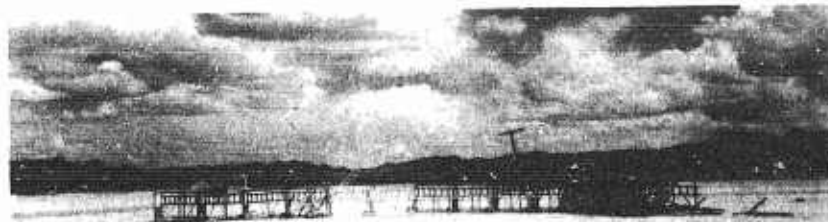
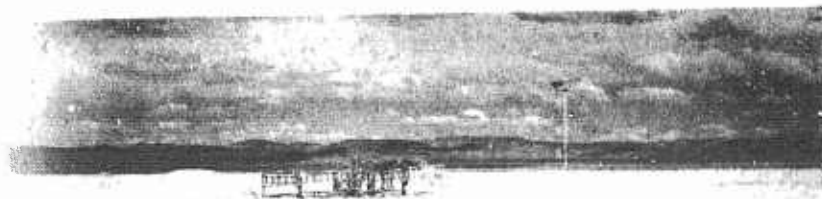
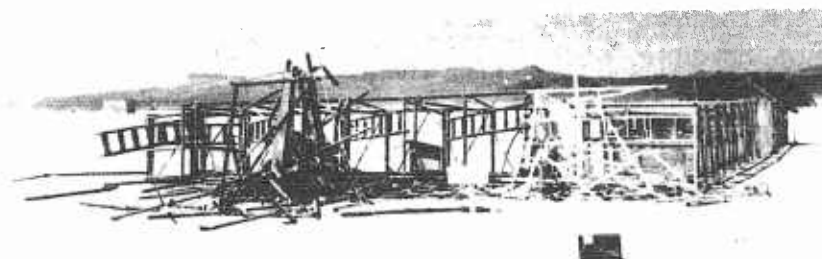
Fig. 3.89 Shot 9, Test Group 34, Tower, 120 ft.
(All after Photos Showing Damage Details.)
4350 ft, 36 cal, 7.2 psi.

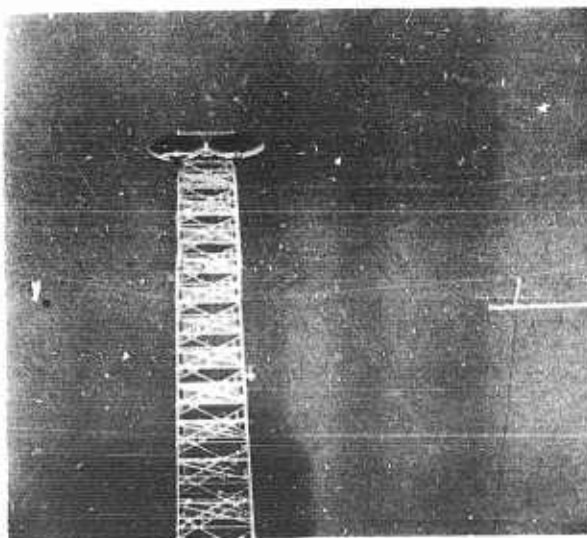
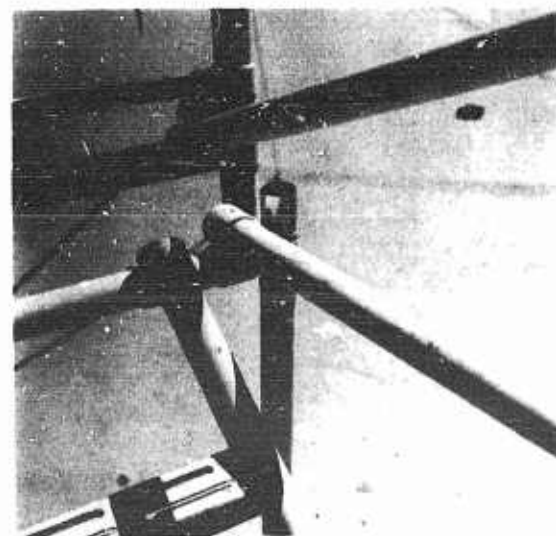
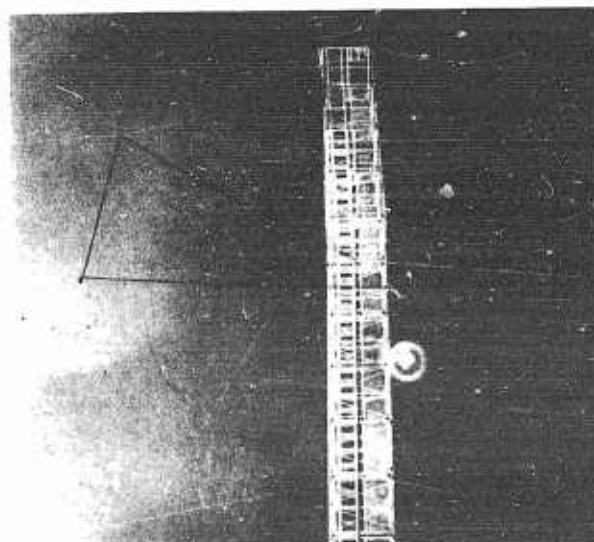
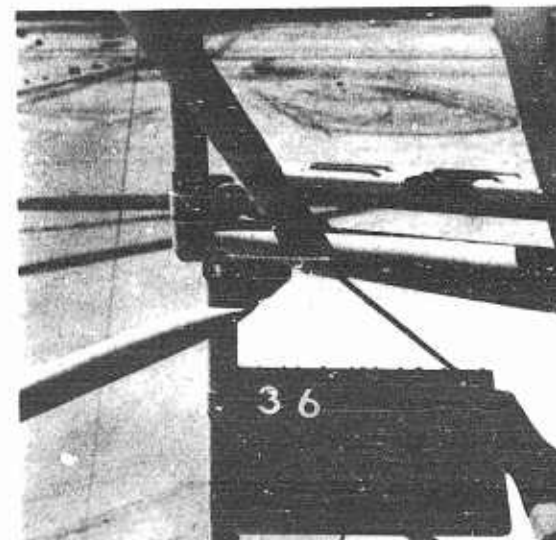
Fig. 3.92 Shot 9, Test Group 36, Tower, 200 ft. After Shot Photos.
 (Top left-Front View, Bottom left-Side View Looking West
 - Note the Deformation at Junction of 5th and 6th Tower
 Sections, Top Right and Bottom Right Show Section Unseated.
 6450 ft, 19.5 cal, 4.6 psi.

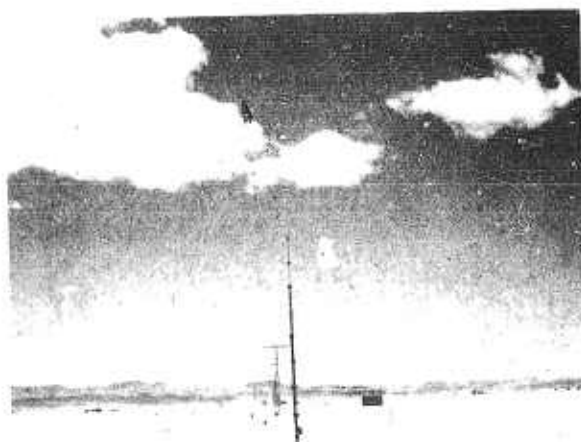
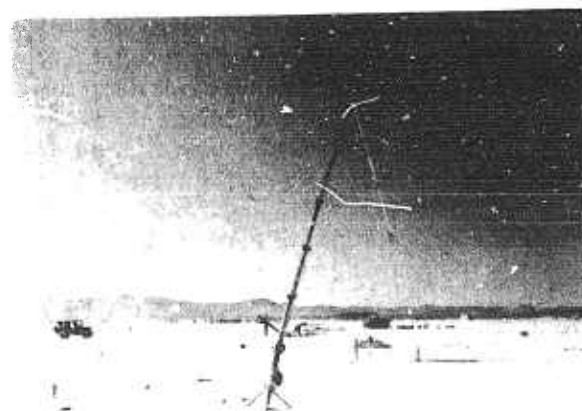
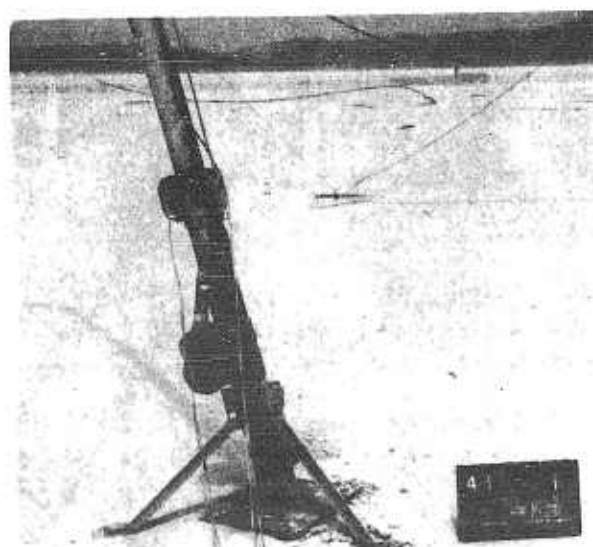
Fig. 3.96 Shot 9, Test Group 41, Antenna Mast AB-224/U. (Top Left-before, Top right-after; Center Close-up of Antenna Base-after) 4625 ft, 32.5 cal, 6.8 psi.

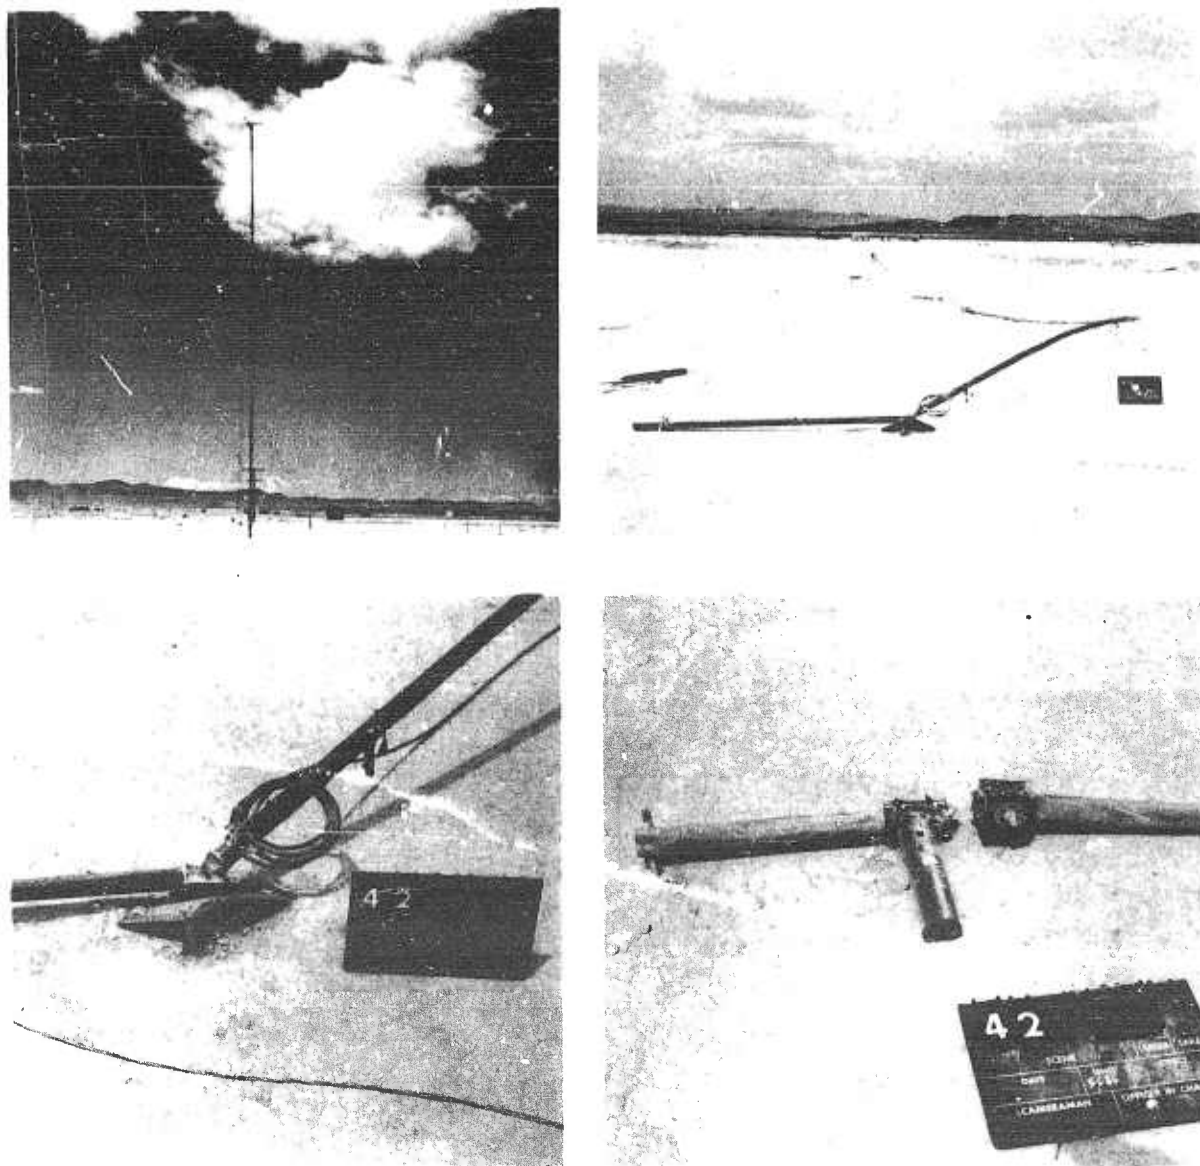
Fig. 3.97 Shot 9, Test Group 42, Antenna System AS-19/TRC-1.
 (Top left-before, Top right-after; Bottom left, Antenna
 Base-after; Bottom Right, View of Break at Top of Mast-
 after.) 4650 ft, 32.5 cal, 6.8 psi.

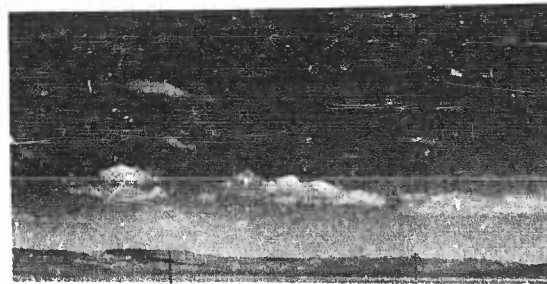
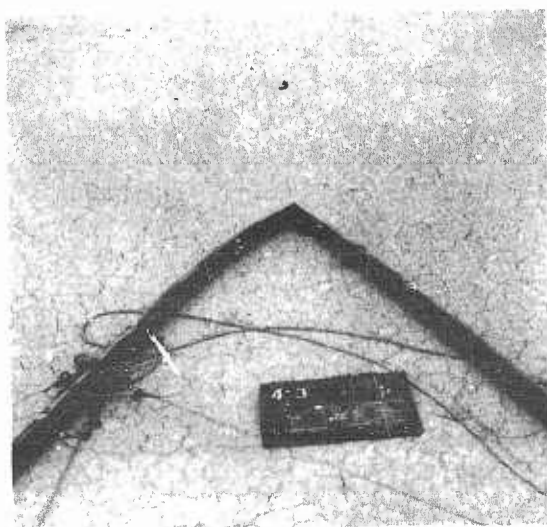
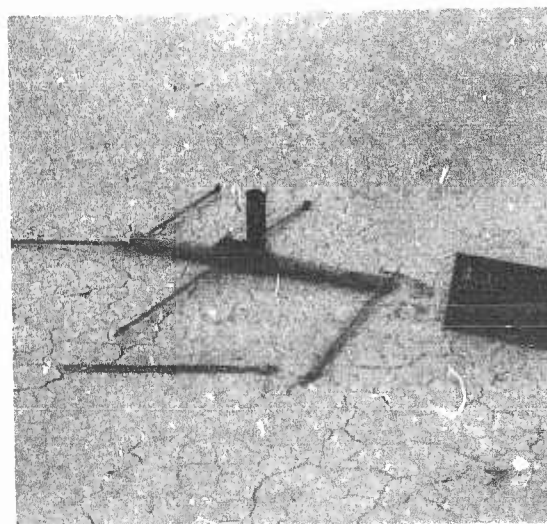
The antenna system received severe damage from the blast forces. The antenna support collapsed. The two top forward nylon guys failed. The top steel mast section, the fiberglass mast section, and the antenna array were separated from the mast. The antenna array was severely damaged by the fall. Three of the elements were broken at the base fitting. The mast section below the first guy level buckled and the four sections above were bent. The coaxial cable was torn free of the cable connector at the upper end. Many of the mast components could be reused. The antenna system received moderate to light thermal damage on the surfaces of all parts facing the blast center. The painted mast sections were slightly charred. The nylon guys, antenna insulators, fiberglass mast section, rubber covered coaxial cable, and the friction tape used to secure the coaxial cable to the masts, were charred but remained serviceable.

Fig. 3.98 Shot 9, Test Group 43, Antenna System, AS-19/TRC-1.
(Top left-before, Top right-after, Bottom left, bent
Mast-after, Bottom Right-Broken Top of Mast)
4900 ft, 29.5 cal, 6.2 psi.

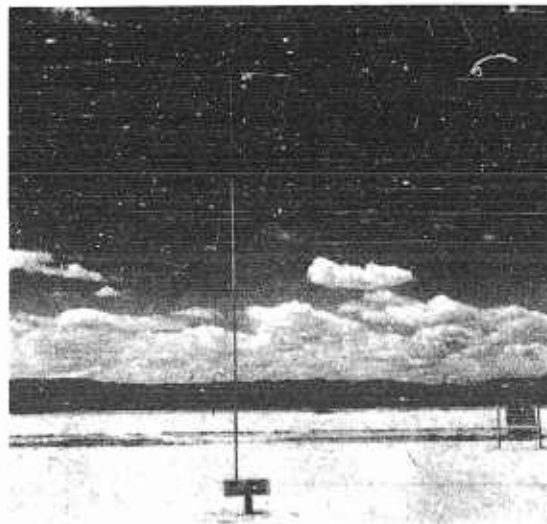
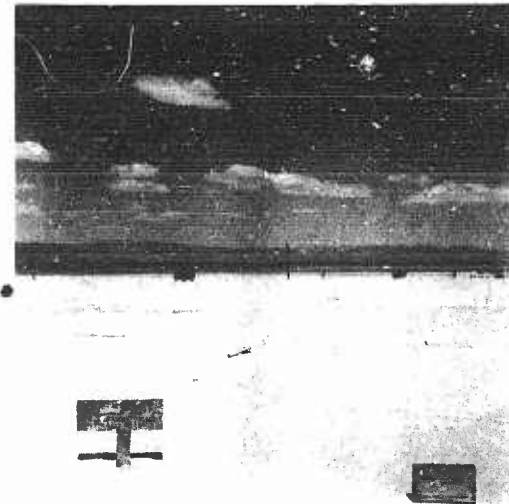
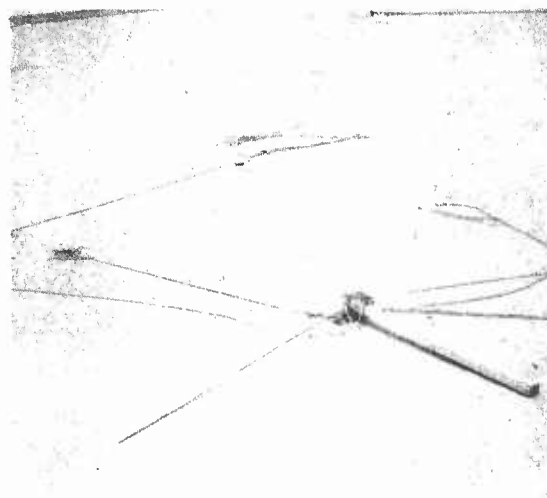
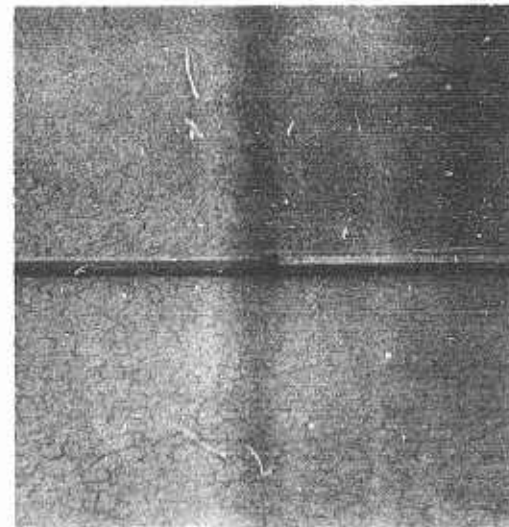
(1) Test Group 45 - located 4925 ft from GZ. The mast received severe damage from the blast forces. Collapse of the mast may have been caused by failure of the forward guy snap retainers on the guy plates. The mast sections were separated and scattered, some as far as 200 ft away. The antenna array was severely damaged. The mast sections and guys remained serviceable. Light thermal damage to dacron guy surfaces which faced the blast center. Fusing of the dacron was somewhat less than for the nylon guys at the same distance from the blast center.

Fig. 3.100 Shot 9, Test Group 45, Magnesium Mast, 30 ft. (Top left-before, Top right-after; Bottom left, Top of Mast-after; Bottom right, Broken Mast Joints-after.) 4925 ft, 29.5 cal, 6.2 psi.

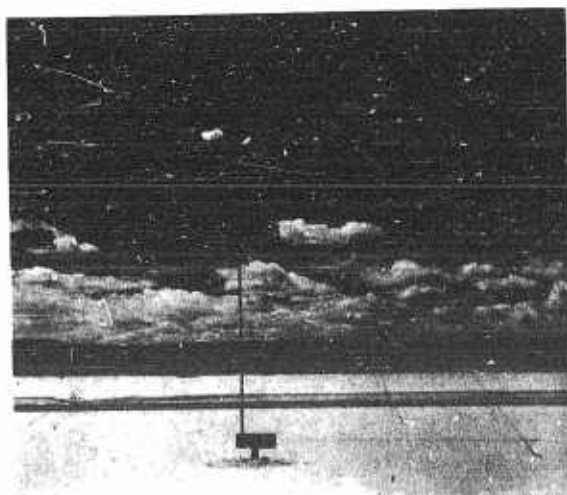
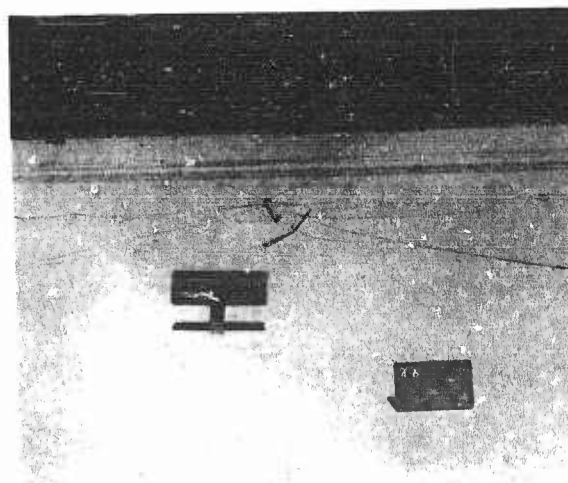
(2) Test Group 46 - located 4950 ft from GZ. Severe blast damage to mast and antenna array. The mast collapsed and as a result three of the antenna elements were broken. Three of the mast sections were broken at joints. Guy snap retainers, on the guy plates at all three guy levels for the forward guys, failed, releasing the guys. Light thermal damage to the nylon guy surfaces which faced the blast center. The nylon guys showed slight evidence of fusing.

Fig. 3.101 Shot 9, Test Group 46, Magnesium Mast, 30 ft. (Top left-before, Top right-after; Bottom, Broken Mast Sections-after) 4950 ft, 29.5 cal. 6.2 psi.

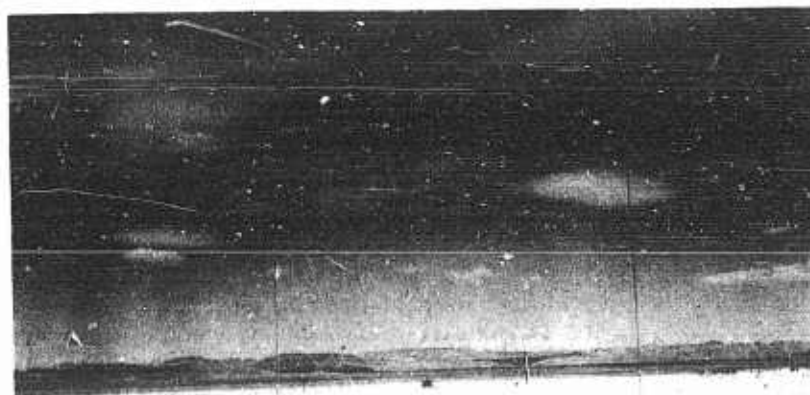
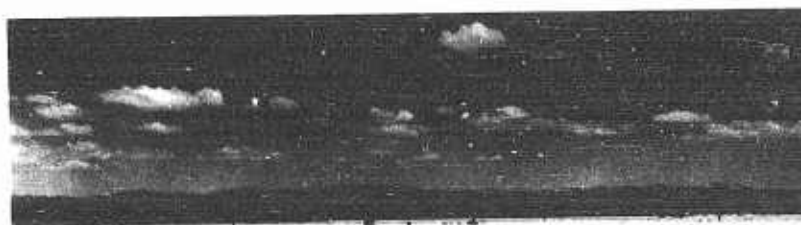
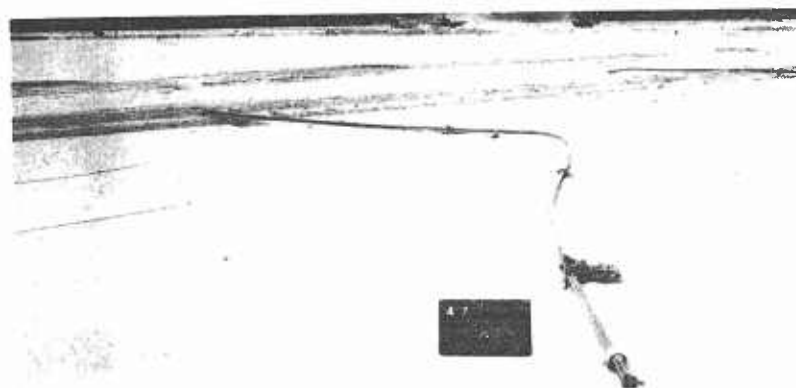
(1) Test Group 47 - located 5000 ft from GZ. The antenna system received severe damage from the blast forces. Both masts collapsed. Several guys failed on both mast installations. Stakes remained in position. The fiberglass base insulators were undamaged by blast or thermal forces. Light thermal damage to the dacron guy surfaces which faced the blast center. Fusing on guy surfaces less than for the nylon guys at same distance from the blast center. The masts were not serviceable.

Fig. 3.102 Shot 9, Test Group 47, Antenna System AN-GRA-4.
 (Top-before, Center-after, Bottom-after)
 5000 ft, 28.5 cal, 6 psi.

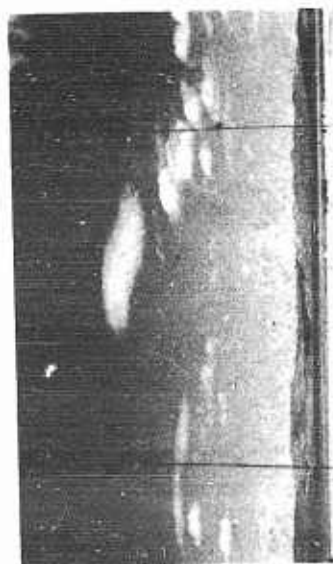
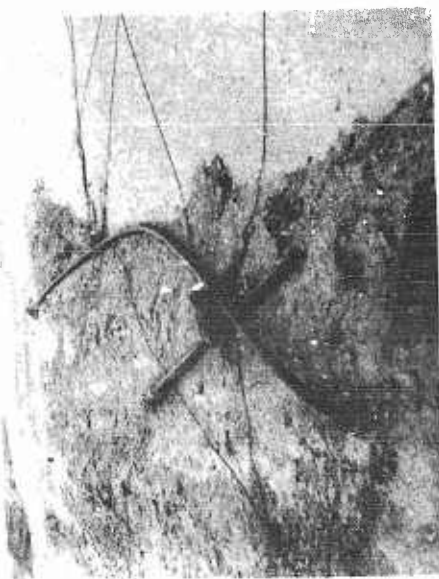
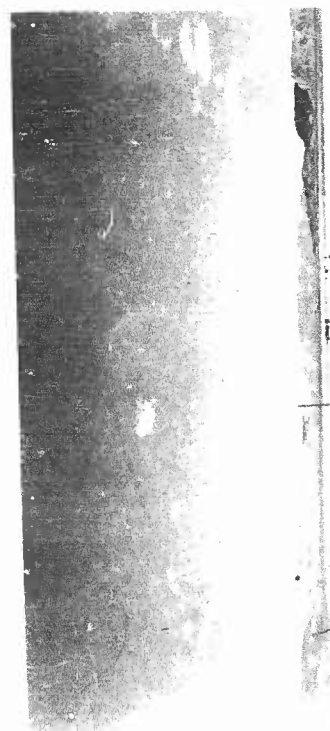
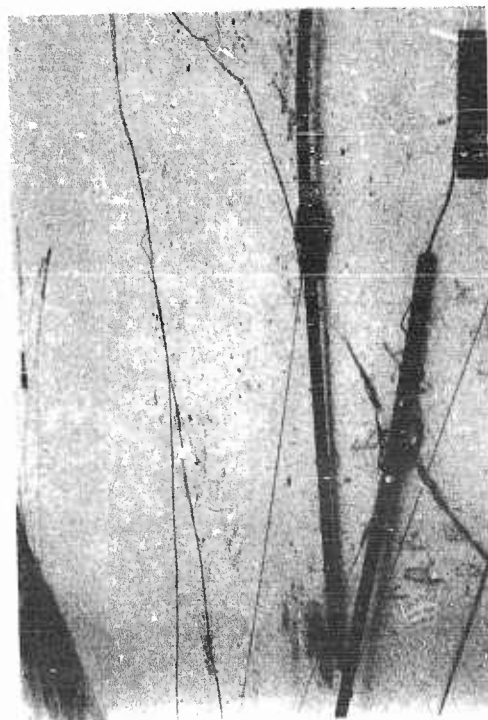
(2) Test Group 48 - located 5000 ft from GZ. The antenna system received severe damage from the blast forces. Both masts collapsed. All guys, guy stakes, hardware items, and the antenna remained intact and reusable. The fiberglass base insulators were undamaged by the blast forces or the thermal radiation. Antenna system was not serviceable. Light thermal damage to the nylon guy surfaces which faced the blast center. Slight fusing was more than for the dacron guys at the same distance from the blast center.

Fig. 3.103 Shot 9, Test Group 48, Antenna System AN/GRA-4. (Top left-before, Top right-after, Bottom left-after, Bottom right-after.) 5000 ft, 28.5 cal, 6 psi.

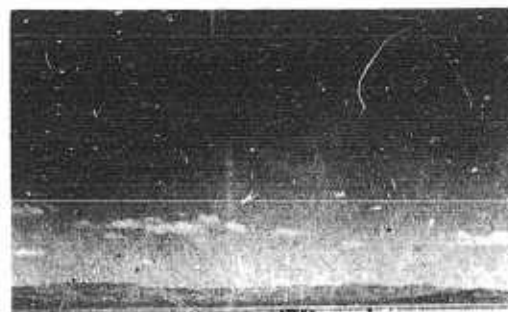
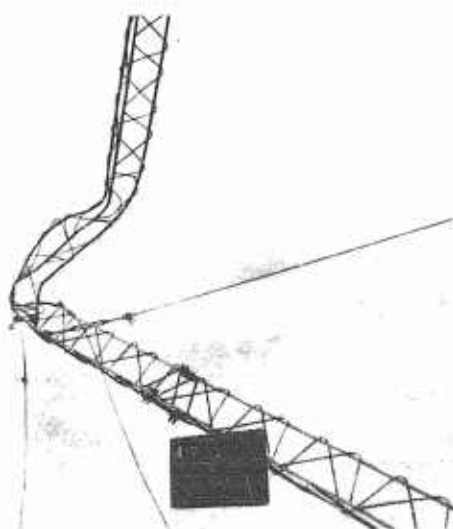
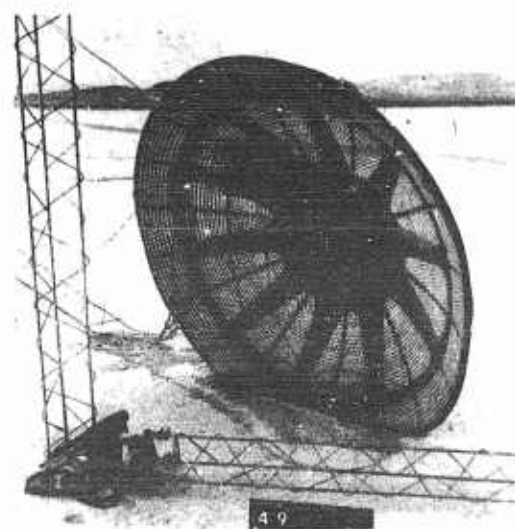
Fig. 3.104 Shot 9, Test Group 49, Antenna Mast AB-26/CR. (Top left-before, Top right-after; Bottom left, Section of Twisted and Broken Mast-after; Bottom right, Reflector-after.) 5550 ft, 25 cal, 5.4 psi.

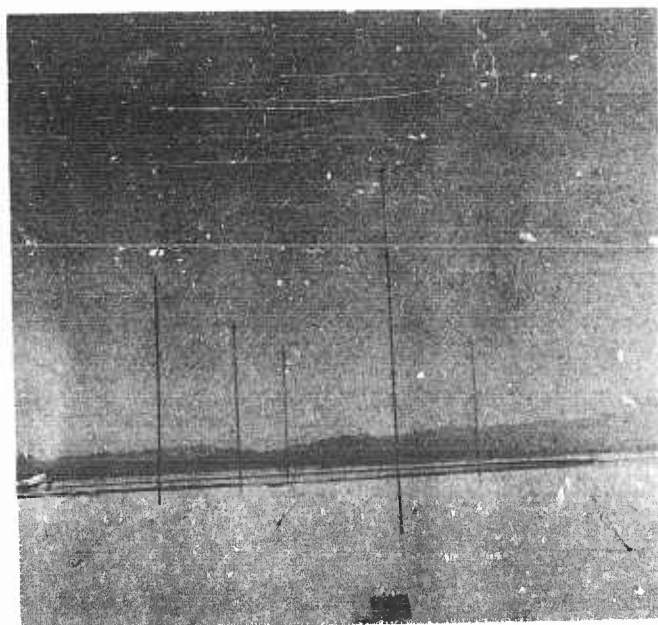
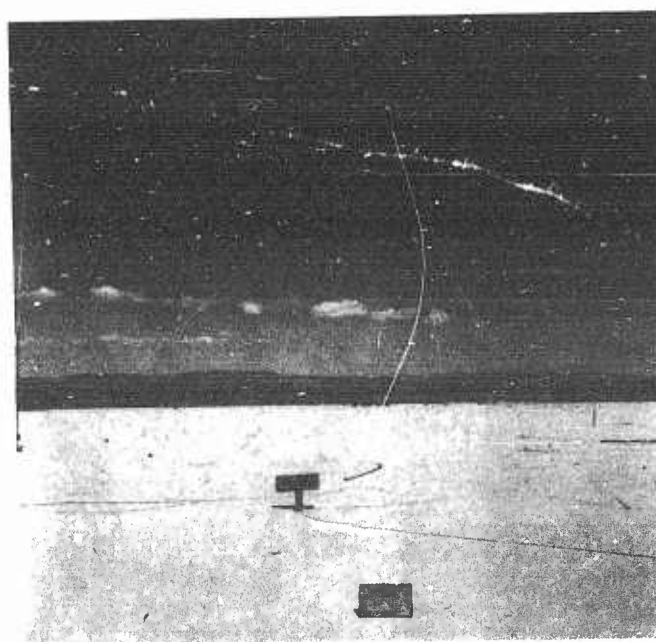
(3) Test Group 51 - located 5550 ft from GZ. Moderate damage by blast forces to the mast. The mast did not collapse. The antenna array was undamaged. Guy snap retainers on guys in the plates of the lower and middle forward guys failed, releasing both guys. The installation remained serviceable, requiring approximately one-half hour to repair.

Fig. 3.106 Shot 9, Test Group 51, Antenna mast Magnesium.
(Top-before, Bottom-after)
5550 ft, 25 cal, 5.4 psi.

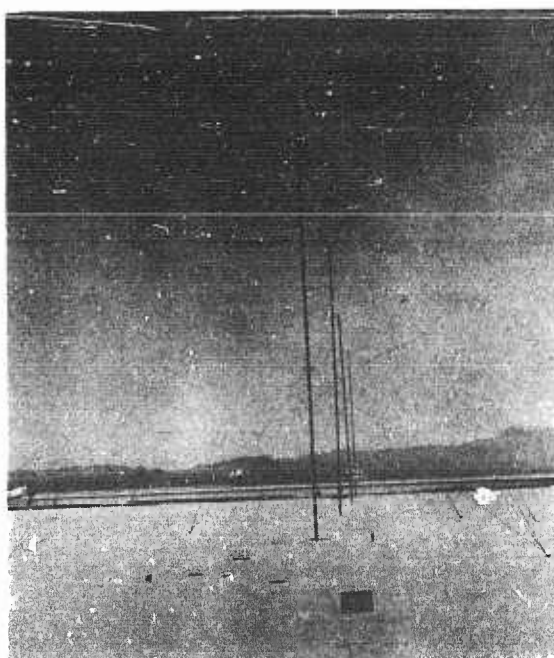
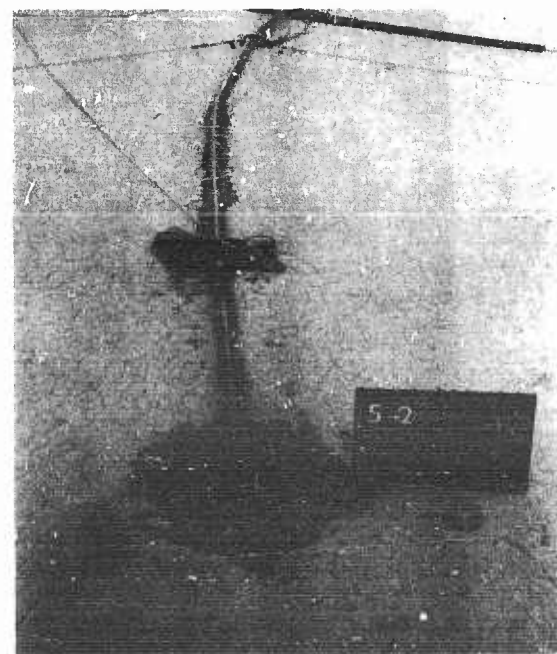
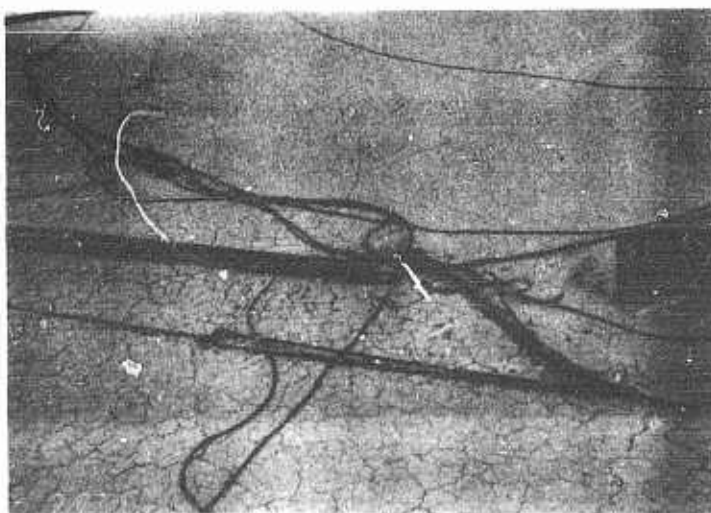
Fig. 3.107 Shot 9, Test Group 52, Antenna Mast AB-155/U. (Top left-before, Test Group 52 in Foreground, Top right-after, Bottom-after) 5625 ft, 24.5 cal, 5.3 psi.

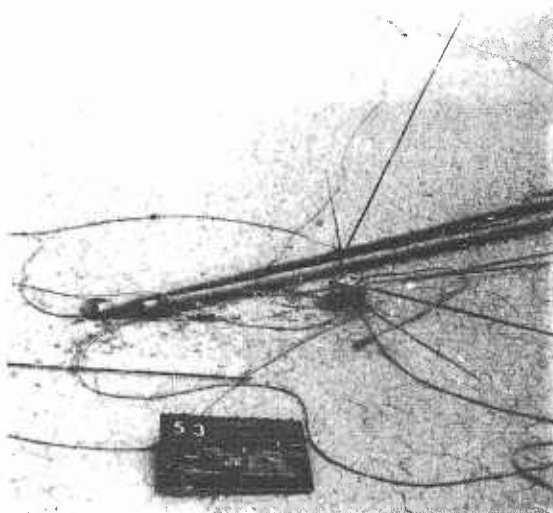
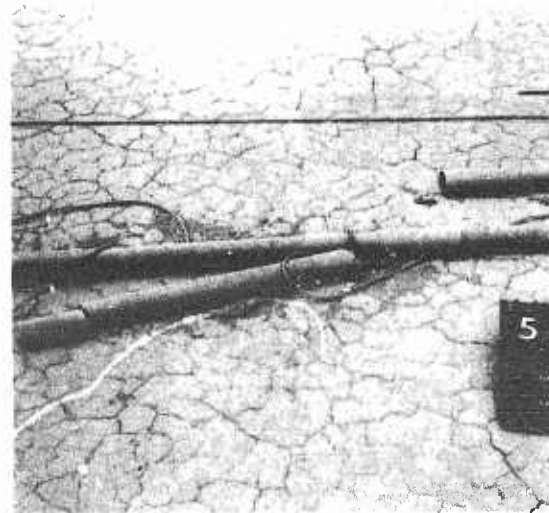
(4) Test Group 53 - located 5575 ft from GZ. Severe blast damage to the mast and antenna array. Damage to the antenna array was due to the mast collapse. Two antenna elements were broken. Three of the mast sections failed at joints. Guy snap retainers, on the guy plates at all three guy levels for the forward guys failed, releasing the guys. Dacron guys received light thermal damage evidencing slight fusing of the surfaces which faced the blast center. Fusing was less than for the nylon guys at the same distance from the blast center.

Fig. 3.108 Shot 9, Test Group 53, Antenna Mast, 30 ft, Fiberglass.
(Top left-before, Top right-after; Bottom left, Broken
Top-after, Bottom right, Broken Mast Section-after.)
5575 ft, 24.5 cal, 5.4 psi.

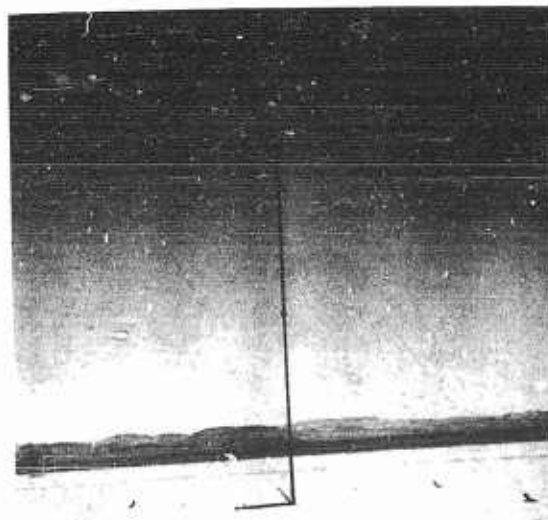
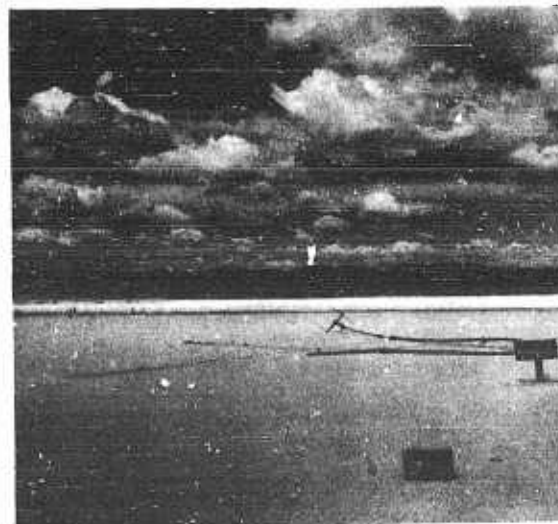
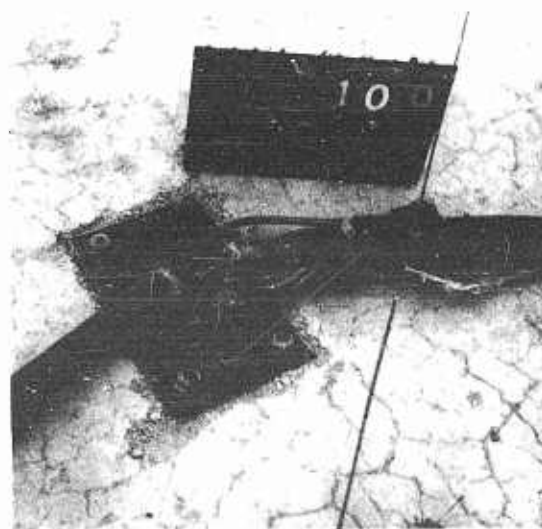
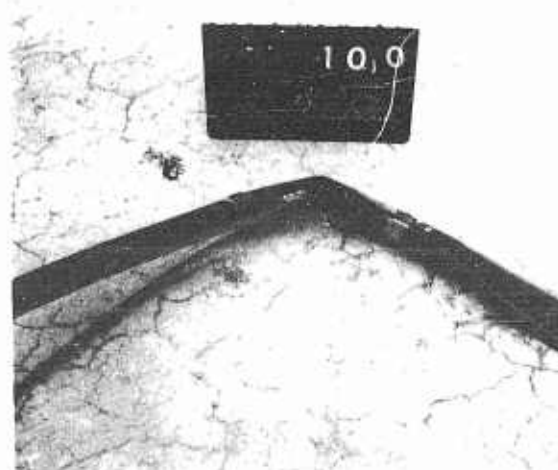
The antenna system received severe damage from the blast forces. The antenna support collapsed. There were no guy failures. The antenna remained attached to the mast. Three of the antenna elements were broken as a result of the fall. The mast base

was severely damaged. The second mast section, below the first guy level, buckled. The first section above and the first section below the buckled section were bent. Guys, stakes and hardware items remained intact and serviceable. The antenna system received light thermal damage on the surfaces of all parts facing the blast center. The nylon guys showed slight evidence of fusing. The plastics used were slightly charred. The rubber covered coaxial cable and the friction tape used to secure it to the mast showed slight evidence of charring.

Fig. 3.110 Shot 9, Test Group 100, Antenna System AS-19/TRC-1.
(Top left-before, Top right-after; Bottom left,
Antenna base-after; Bottom right, Bent Mast Section-
after.) 6350 ft, 19.5 cal, 4.6 psi.

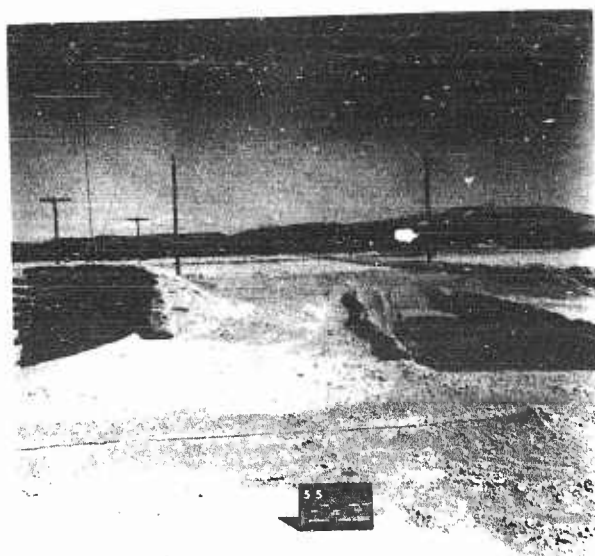
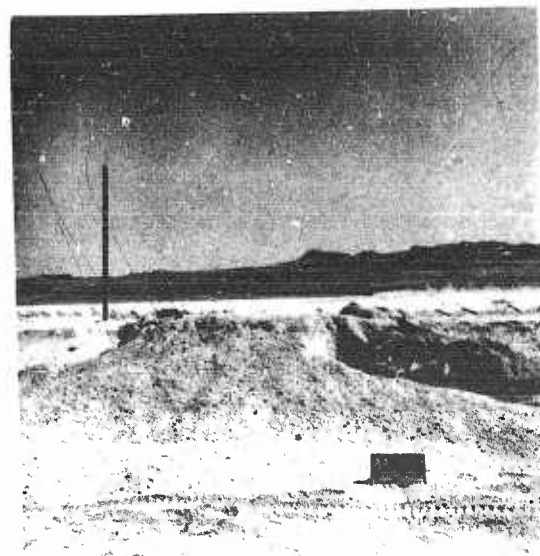
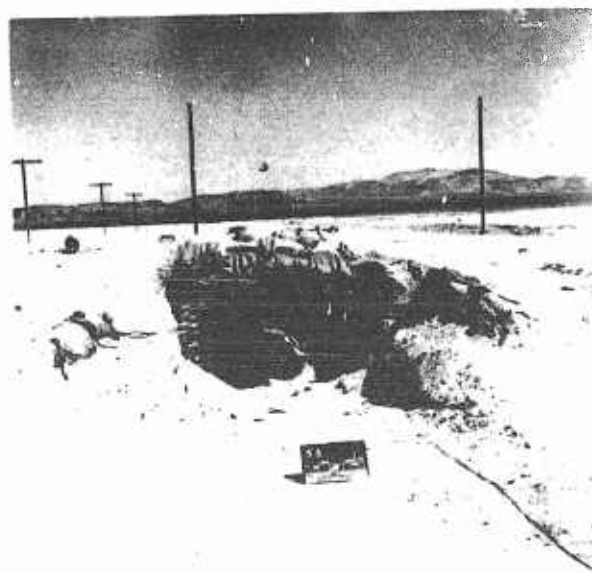
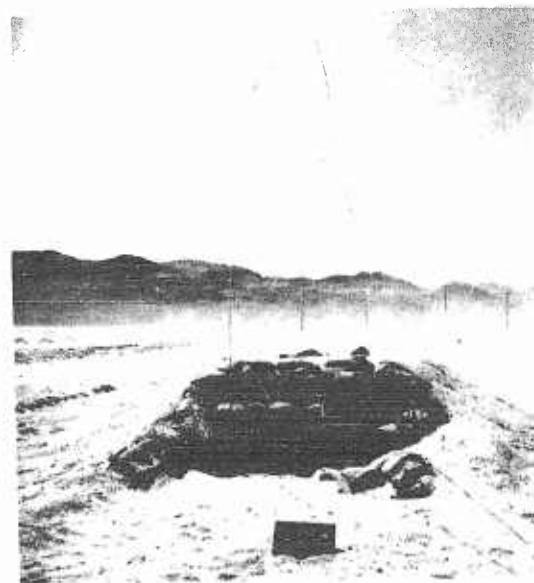
Fig. 3.111 Shot 9, Test Group 55, AN/GRC-26 Radio Set (Revetted).
(Top left-before, Bottom left-after, Top right, Side
View-after, Bottom right, Rear View-after.) 1700 ft,
91 cal, 13.8 psi, 3600 r at Surface, 572 r in S-56
Shelter.

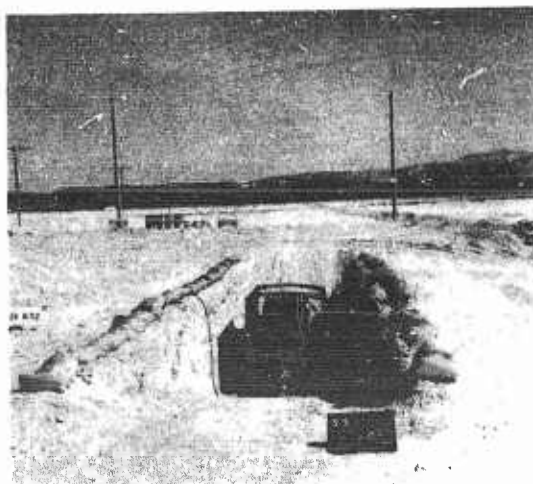
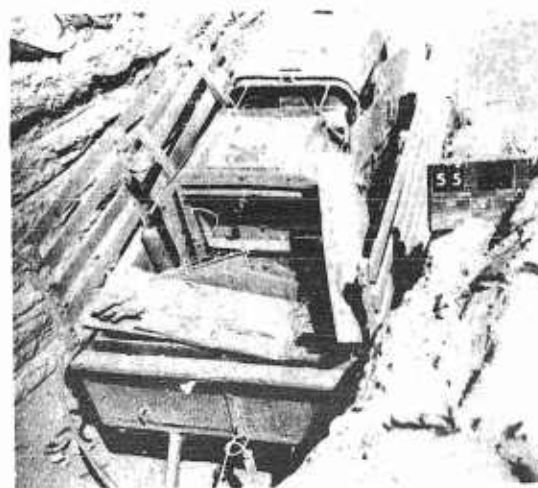
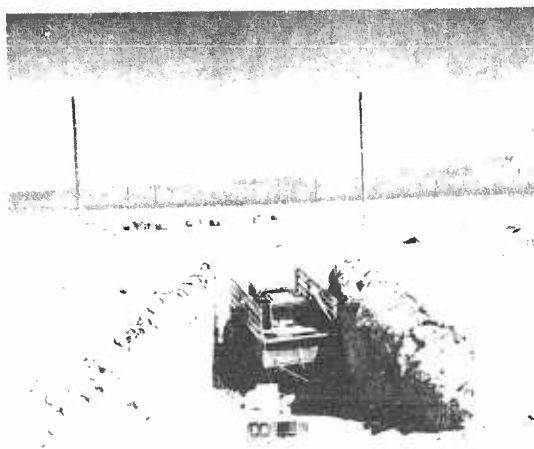
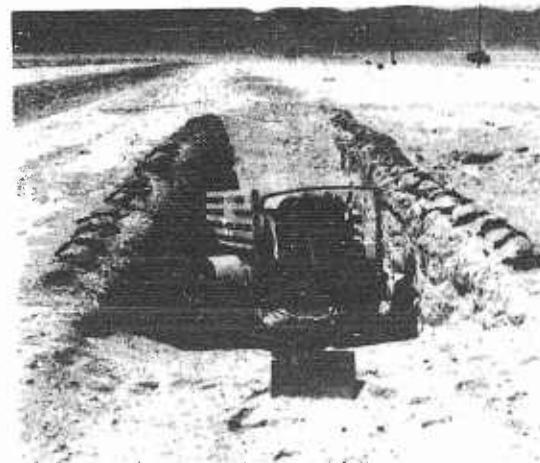
Fig. 3.112 Shot 9, Test Group 55, PE-95 Power Unit, part of AN/GRC-26 Radio Set. (Top left-before, Bottom left-after, Top right, Front View-after, Bottom right, Rear View-after.) 1700 ft, 91 cal, 13.8 psi.
